Corrosion failure of titanium tubes of a heat exchanger for the heating of dissolving lye

Corrosion of titanium heat exchangers in the processing of sylvinitic ore is undesirable from economic, safety, and process sustainability perspectives. Triggered by an industrial case, we investigated the extent of corrosion during simulated contact with sylvinitic ore (in dissolving lye) in relevant conditions. Detailed characterization of the failed tubes and corrosion products was carried out to understand the mechanism of failure. Corrosion of titanium (Grade 2) tubes was investigated at room temperature, 60, 70, 80, and 90 °C. After electrochemical and surface morphology analysis, we found that pitting corrosion of the titanium tube material sharply increased above 80 °C in the simulated sylvinitic ore environment (pH 7.1). The failure analysis revealed extensive degradation by transgranular cracking through both the oxide and metal matrix, likely caused by a combination of the high temperature, pressure, possible vibrations, the build-up of lye deposits causing crevices, the high salt content of the lye, and possibly metal (copper, iron, zinc) impurities/deposits in or on the titanium

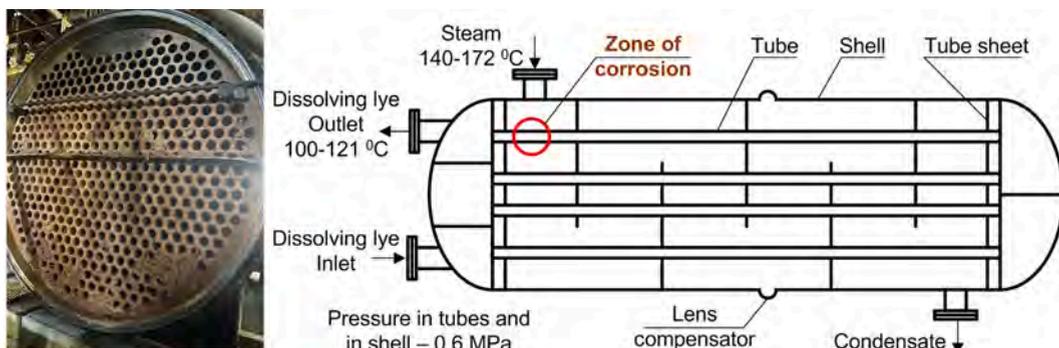
Fig. 1. Picture of outlet showing lye deposits (left) and schematic of shell and tube type titanium heat exchanger (right).

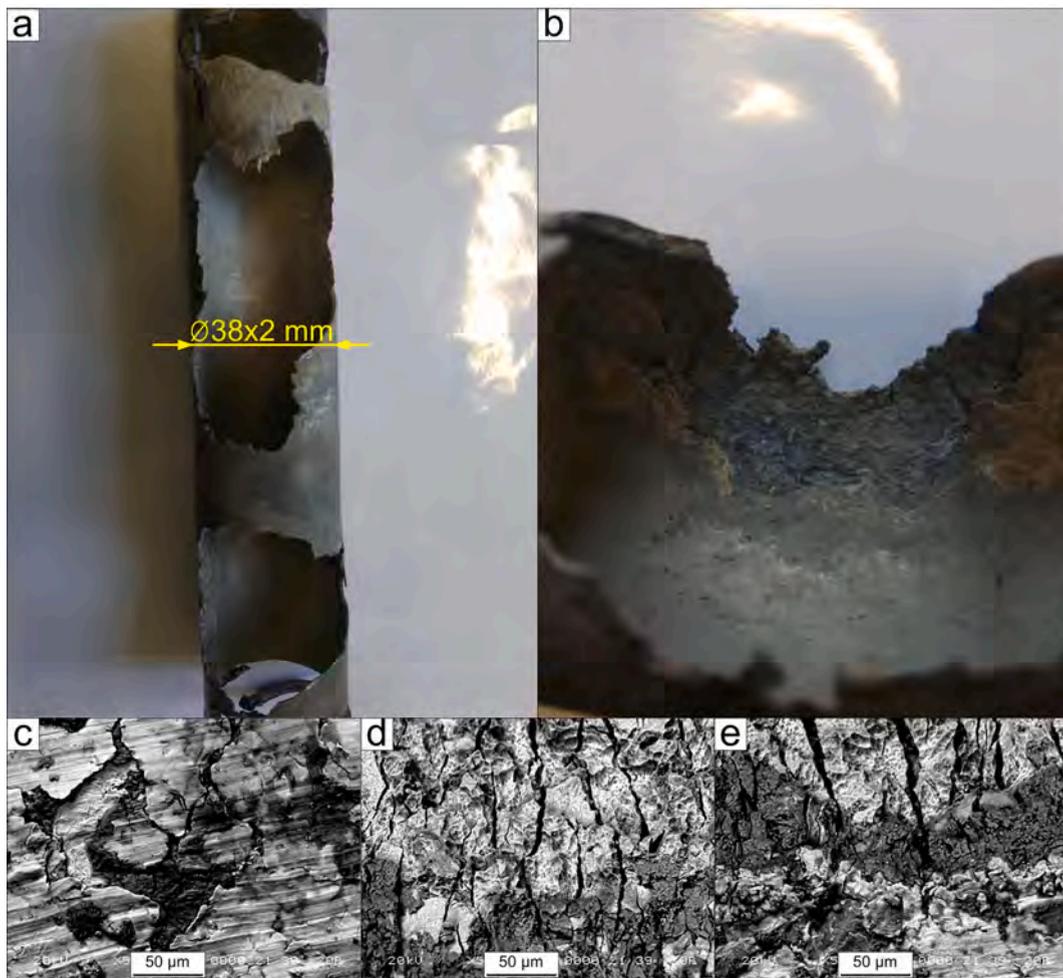
Fig. 2. Photographs (upper row) and SEM images (lower row) showing millimeter and micrometer-sized cracks and visible corrosion and failure.

Fig. 2 shows photographs and SEM images of corroded titanium tubes of the heat exchanger used to heat dissolving lye. The photographs (upper two rows in Fig. 2) show millimeter to centimeter-sized holes. The corrosion started from the inside of the tube.

During the maintenance once in three months, the condition of the pipes was checked only visually. In the problem area, this visual inspection should be complemented by non-destructive methods such as ultrasound (to measure the thickness of the pipe), acoustic testing (to distinguish brittle from ductile metal and detect cracking), and electrochemical measurements (to detect the onset of active corrosion by a lower than usual potential). Further, frequent removal of corrosion products from process streams is essential to avoid the formation of crevices and thick deposits that cause overheating. Such Fe-containing deposits may lead to a greater hydrogen

evolution and a greater extent of cathodic reactions [4], resulting in greater hydrogen-induced cracking. Surface modification of titanium tubes by pickling, passivation and thermal oxidation can be considered to minimize corrosion attack and hydrogen-induced cracking [7,14].

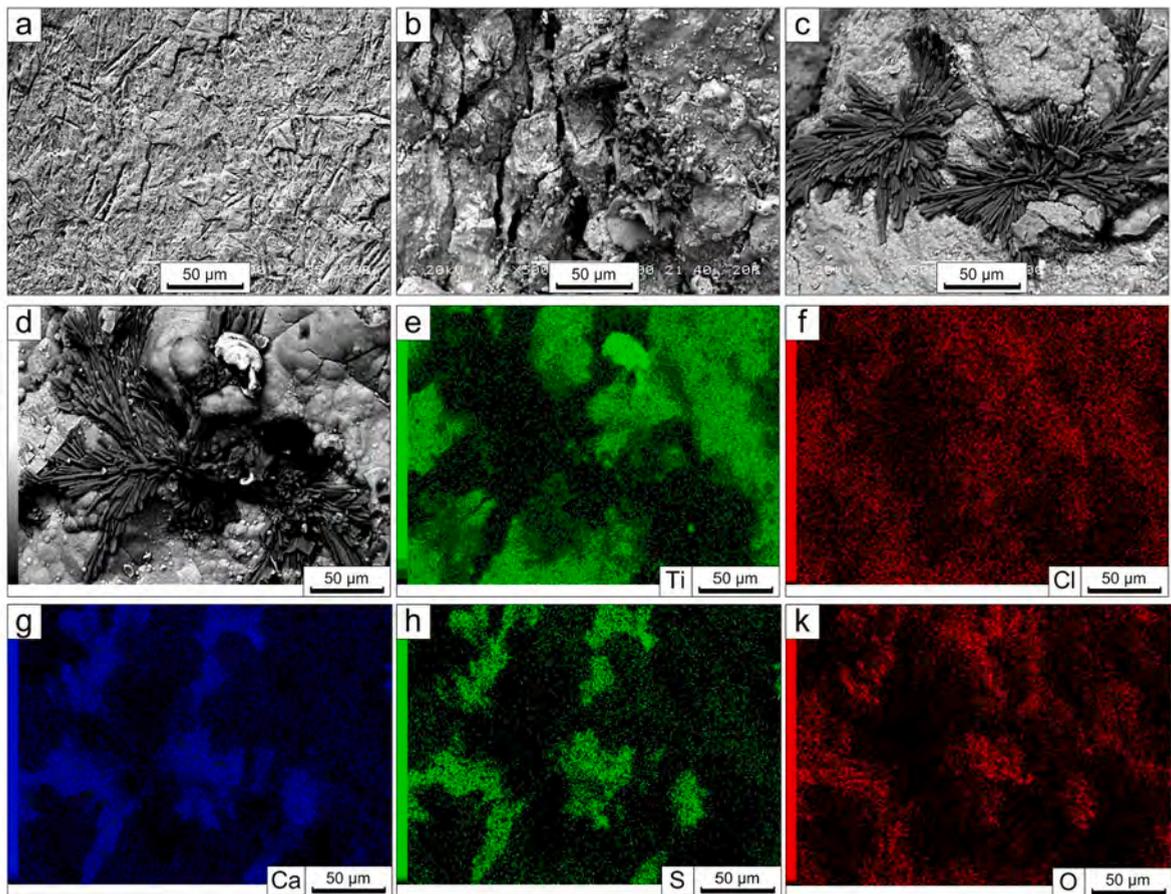
In order to investigate which substances took part in the extensive corrosion of the titanium tubes, the corrosion products were analyzed. SEM images are presented in Fig. 3 and corresponding EDS results are shown in Table 2.

The composition of corrosion products, by means of EDS analysis, is shown in Fig. 3 and in Table 2. EDS analysis showed a higher value of Fe for the titanium metal of an unaffected area than did the chemical analysis provided by the supplier (Table 1), suggesting some preferential deposition of Fe impurities from the dissolving lye. Fe, as well as copper (Cu) and zinc (Zn) can catalyze cathodic reactions on titanium metal [18]. Fe, Cu, and Zn are even more enriched in the corroded area (Fig. 3b, Table 2). Deposits (Fig. 3c, Table 2) contain small amounts of these and other impurities, and mainly the dissolving lye main insoluble components (Ca, S, O).

Fig. 3. SEM images of an unaffected titanium tube (a), corroded area (b), and sediments (c-d) with corresponding (to d) EDS mapping results (e-k).

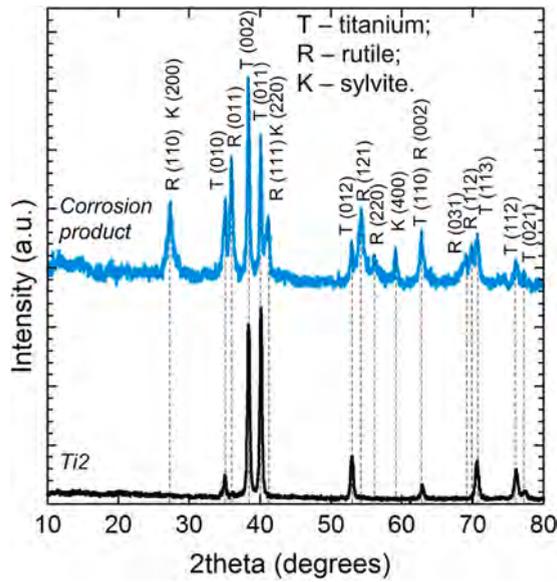
XRD patterns of the corrosion products showed peaks of titanium metal (hexagonal crystal system and $P63/mmc$ space group), rutile (tetragonal crystal system and $P42/mnm$ space group) and sylvite (cubic crystal system and $Fm3m$ space group), Fig. 4. The main content of the corrosion products was titanium dioxide (rutile). Sylvite was found in the corrosion product samples in a minor concentration and some deposited crystals of calcium sulphate were also found.

Fig. 4. XRD diffractograms of corrosion products and bulk titanium (for comparison).

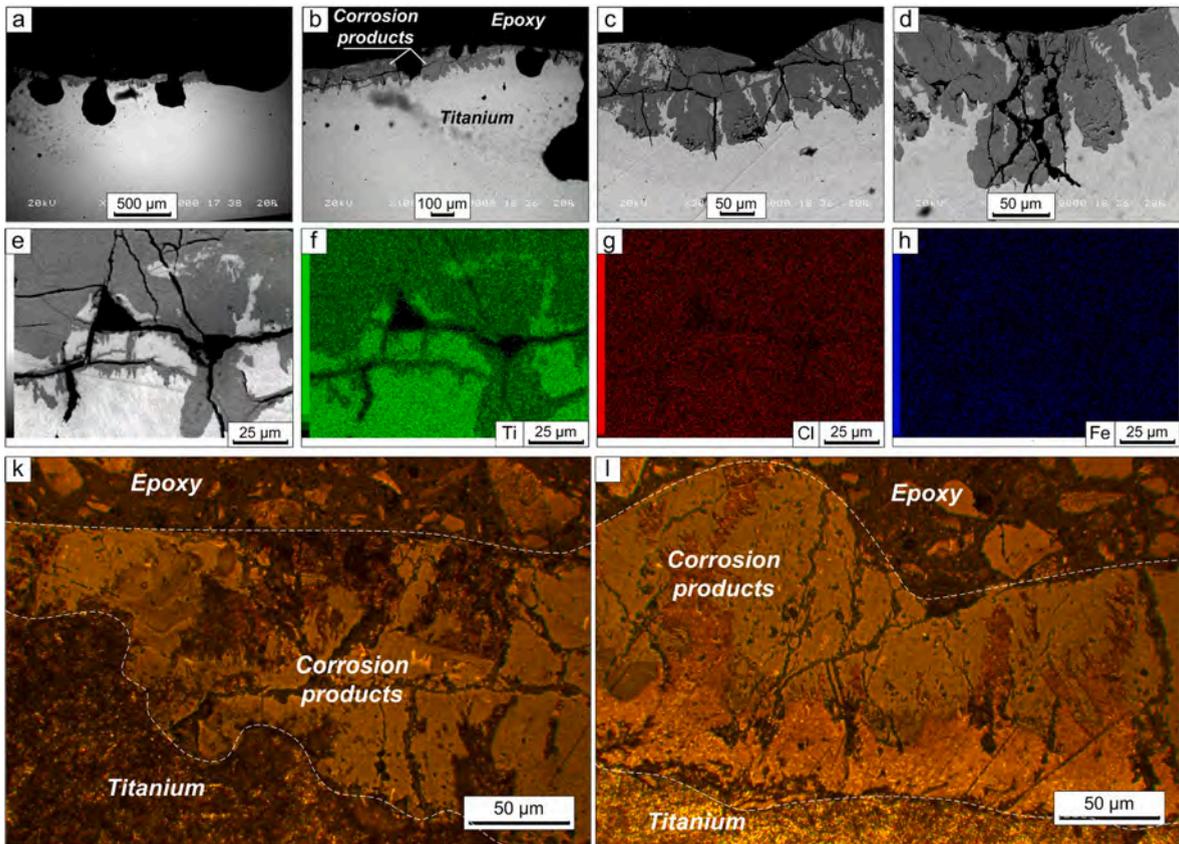
To determine whether intergranular corrosion and stress corrosion cracking could have played a role, the cross-section of the corroded specimen was mapped by EDS (Fig. 5). Cracks passed through the titanium oxide and continued into the metal, which is unusual for a corrosion-induced cracking type. Likewise, chlorine was not concentrated at the crack tips or along the cracks. This suggests that the titanium metal could have been embrittled by hydrogen and/or that there were large stresses, facilitating a rapid propagation of the cracks. The distribution of Fe did not imply the participation of Fe (itself) in the corrosion process, but it could have been a catalyst for the evolution of hydrogen and, therefore, increased hydrogen embrittlement. To conclude, neither intergranular corrosion nor stress corrosion cracking or oxide-induced stress corrosion cracking seemed to be the dominant corrosion propagation mechanism, and a rapid cracking propagation was found. It should be noted that there were no vibrations or other loads during operation of the heat exchanger. There were also no frequent or large temperature variations. When disrupting the processing for maintenance (once every 3 months), only mechanical cleaning and further rinsing with water were used.

Fig. 5. Cross-section by SEM (a-d), cross-section and corresponding EDS mapping (e-h), and optical microscope images (k and l).

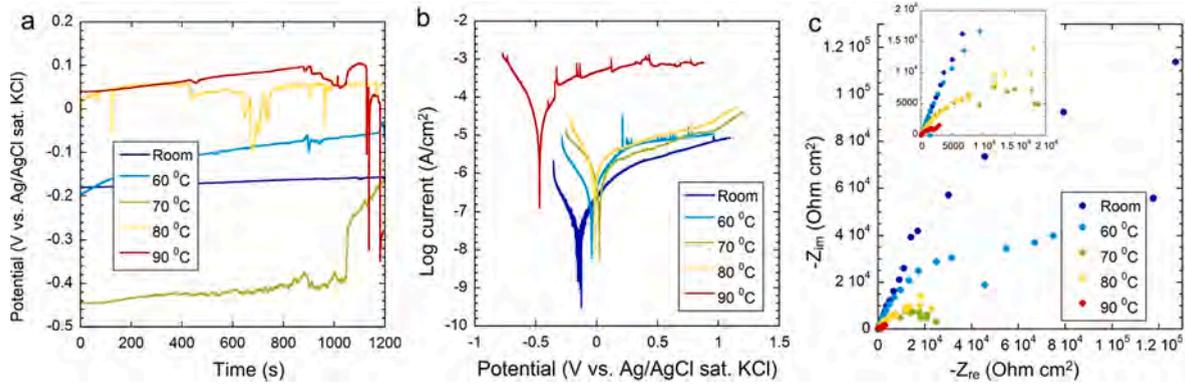
All these corrosion parameters point towards a serious breakdown of passivity at 90 °C, while there are minor differences up to 80 °C.

Fig. 6. Representative curves of OCP (a), potentiodynamic polarization (b) and EIS (c) at room temperature, 60, 70, 80, and 90 °C.

The shape of the Nyquist curve (Fig. 6c) at 90 °C, as compared to the other temperatures, suggests a change from a protective surface oxide to an oxide with possible diffusion.

The strong influence of the temperature above 80 °C suggests that the temperature difference between the corrosion-affected outlet zone (maximum temperature of heat exchanger) and the rest of the titanium tubes of lower temperature might play a role in the rapid corrosion propagation. The relatively small area of higher temperature could have been activated and the relatively large area of lower temperature could have fueled the anodic part-cell corrosion process by providing the surface area necessary for the cathodic reactions. These data are in good agreement with paper [12], which noted crevice corrosion of titanium alloys of Grades 2 at 80 °C in seawater. Another study on titanium of Grade 2 in 0.27 M NaCl found a film breakdown and repassivation transients at a temperature threshold of around 65 °C, initiating crevice corrosion [13].
