# A spectroscopic study of leak failures in cross-linked polyethylene tubing used in domestic water supply systems

Recent leak failures in cross-linked polyethylene tubing from several US locations have been studied using microscopy and microscopic spectroscopy. Such failures compromise the use of a material that has been regarded as more environmentally sustainable. The failures appear to be the result of local chemical attack by aqueous chlorine that reacts with the polymer, leading to its oxidation, decrystallization and expansion of its volume. This creates stress fields that lead to chemically induced cracking of the polymer and, eventually, failure of the tubing. Each failure studied in this work was found to be associated with a micro-protrusion in the inside diameter of the tubes; it is proposed that turbulence in the water flow behind the protrusion may accelerate local mechanical and chemical attack of the polyethylene tubing. A simple inspection method is suggested to detect the presence of such protrusions before installation of the tubing. Copyright © 2017 John Wiley & Sons, Ltd.

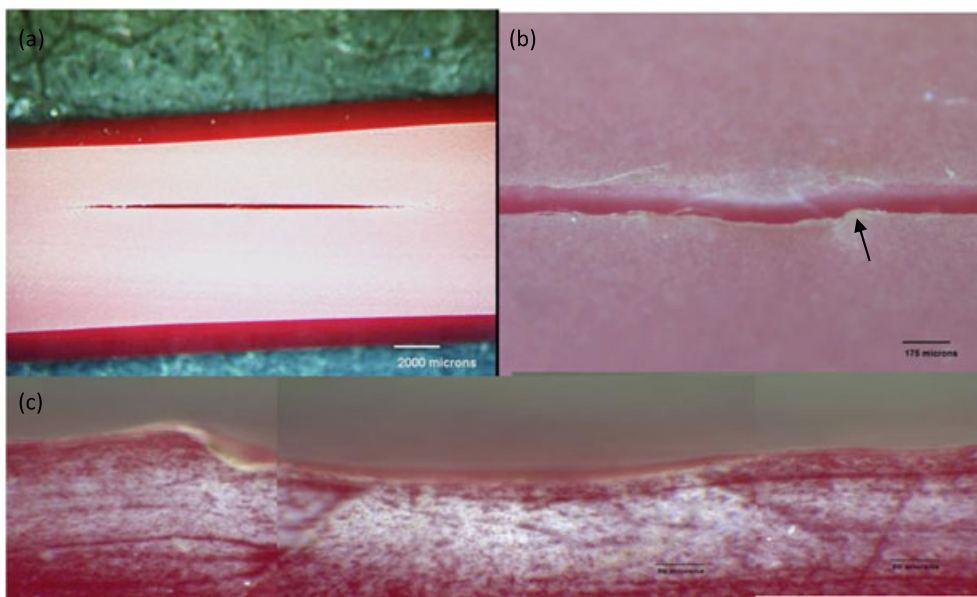
Optical microscopy studies of all PEX pipe failures showed that they were through-wall cracks (not pinholes). On the ID of the pipe, other partial through-wall cracks could be identified, thus showing that the cracking clearly originated on the water side of the tubing. The through-wall and partial cracks observed from the ID side of each sample from all locations were very similar in appearance. The crack (L1–2) shown in Fig. 1a from location 1 extends along the tube length for several millimeters with its widest gap near the median point. Magnification of that region (Fig. 1b) reveals a raised feature or protrusion (arrow) that is more clearly seen in cross section in Fig. 1c. The tube surface to the immediate right of the protrusion appears to be slightly dished. Similar protuberances were found near the median point of all leak failures from all three locations investigated.

**Figure 1.** (a) Optical image of a through-wall crack on the inside diameter side of L1-2; (b) optical image of the region near the median point of the crack in (a); and (c) composite optical micrograph of the cross section after separation of the crack. The outermost layer of the stressed polymer in (c) appears to have a different reflectivity than the underlying polymer. [Colour figure can be viewed at [wileyonlinelibrary.com](http://wileyonlinelibrary.com)]

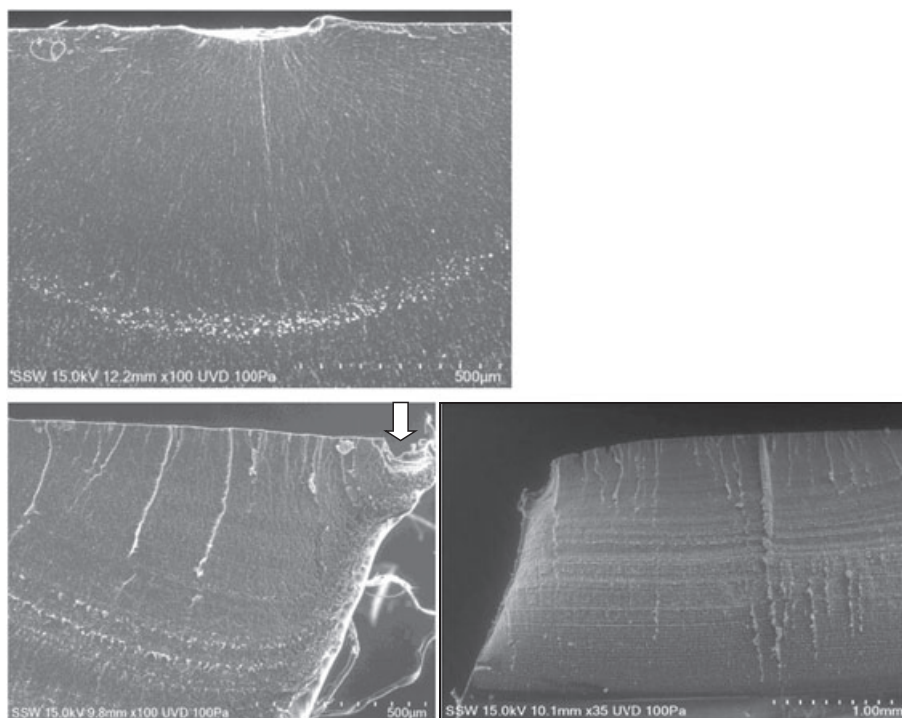
Detailed microscopic images of two other leak failures are shown on Fig. 2 using scanning electron microscopy in low-pressure mode. These are from L1–1 and L2–2. The cross sections of the tube walls are shown with the ID uppermost in the image. Detailed examination of the crack face for the L1–1 failure (Fig. 2a) reveals lines radiating from the dished area; these are thought to be micro

**Figure 2.** (a) Scanning electron micrograph of the cross section of the crack surface of L1-1 taken in low-pressure mode. The inside diameter is at the top of the image, and the protrusion is indicated by the arrow. (b and c) Scanning electron micrographs of the cross section of failure L2-2. The section split into two pieces during sectioning: each image shows one of the pieces.

cracks resulting from strain gradients that would radiate in all directions as a result of volume changes. In addition to the apparent strain features, there is a concentric arrangement of many features that are focused on the protrusion. These concentric features have been shown by EDX to be deposition products from the water (e.g. alkaline elements); these are believed to be deposited from solution

near the crack tip as it advances, thus leaving a 'map' of the path of the crack. Because the crack advances are driven by a stress vector, the concentricity of the rings also suggests that the stress originates at or near the protrusion in each case. Just as with the previous crack failure examples, a dished region in the ID (arrows) is observed adjacent to the protrusion. Fig. 2b shows a similar region

found for L2-2; in this case, the depression is quite pronounced. The raised protuberance is just visible on the extreme right hand of the image. Lower magnification images of both failures (not shown here) allow the region of slow crack growth during aqueous attack to be distinguished from the region of rapid mechanical failure.

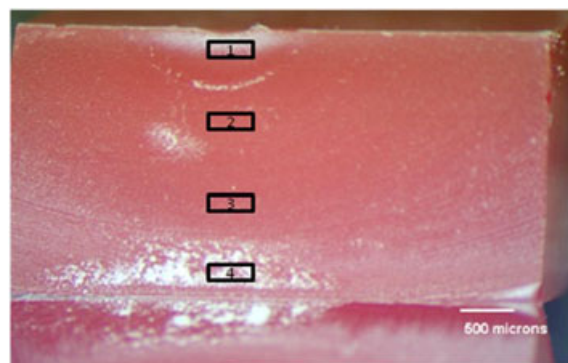
Figure 4 shows an optical microscope image of L1-2, with the tube ID at the top of the image and the outer diameter at the bottom of the image. As with all other cracks studied, a protrusion and a dished region can be identified on the ID side near the center focus of the concentric rings on the crack surface. Quantitative compositional information of the surface of the crack face was obtained using microscopic XPS measurements. Four different areas analyzed by XPS are indicated by the numbers and the boxes. Each XPS spectrum showed peaks for carbon and oxygen, along with those for a number of minor elements that either were deposition products or were present in the original polymer as impurities. The percent oxidation of the PEX itself could be determined by subtracting the inorganic oxygen from the total oxygen. The concentrations of polymeric oxygen in the four areas were determined to be (i)  $4.2 \pm 0.4\%$ , (ii)  $3.5 \pm 0.3\%$ , (iii)  $2.8 \pm 0.3\%$ , and (iv)  $1.8 \pm 0.2\%$ . An analysis of the line shapes of the carbon C(1s) peaks showed the polymeric oxygen to be primarily singly bonded as if inserted in the hydrocarbon chain ( $-C-O-C-$ ). Lower concentrations of carbonyl and carboxyl groups were also detected. Chloride was detected all along the crack face with the highest contributions in area 1 (0.6% of all elements present). Analysis of the chlorine line shape showed that most of it was present as an ionic residue, but there was also some chlorine bonded to the PEX polymer.<sup>[15]</sup> Such a chlorine functionality could be an intermediate that leads to an insertion reaction with water.

**Figure 4.** Optical micrograph of the same crack face as in Fig. 2a (L1-2) with the tube inside diameter at the top of the figure. Four regions are indicated that were analyzed by XPS. Region 4 lies within that portion of the crack that was believed to have opened by mechanical failure. The white areas are deposits of inorganic salts from the water passing through the leak created by the crack. [Colour figure can be viewed at [wileyonlinelibrary.com](http://wileyonlinelibrary.com)]

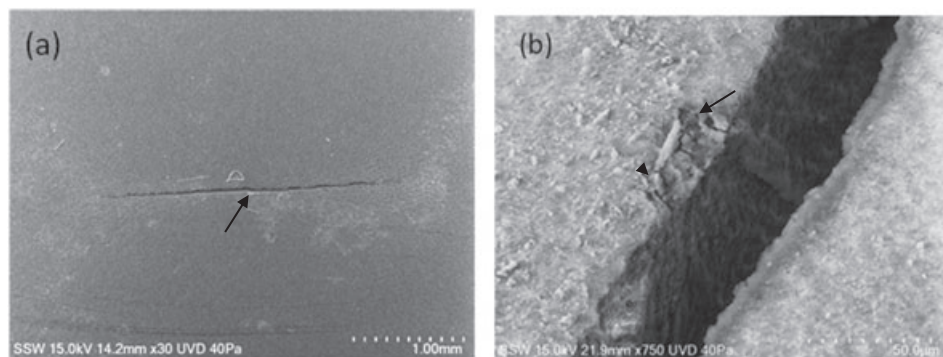
Figure 3 shows the detail of failure L3-1. As in the other cases studied, a protrusion above the ID surface was also found near the mid-point of the crack. In this case however, the protrusion was irregular in shape and appeared to have undergone localized degradation.

**Figure 3.** Scanning electron microscopic images of a crack from L3-1. (a) Image of the inside diameter crack with an irregularity near the mid-point of the crack. Both ends of the crack have crazing extending from the crack. (b) A higher magnification image of the irregularity near the crack mid-point. Unlike the smooth protrusions from the crack inside diameter surfaces found for L1 and L2, this protrusion is quite irregular.

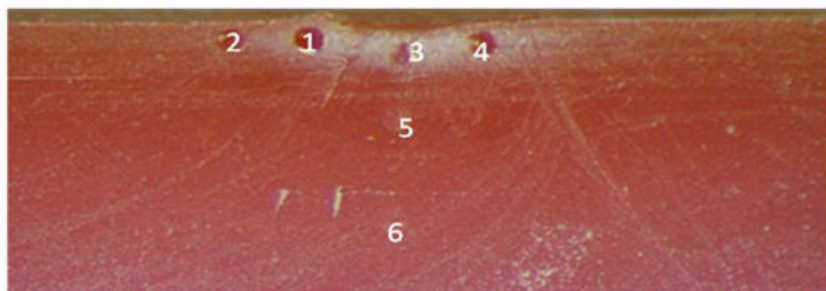
Microscopic FTIR measurements were obtained on cross sections of several failures. Figure 5 shows an optical image of the cross section of failure L1-2 and indicates by numbers where a series of local microscopic infrared measurements were made. The CI [ratio

of the carbonyl ( $C=O$ ) stretching frequency to the carbon-hydrogen stretching frequency] provides an alternative measurement to XPS to measure the extent of polymer oxidation. At points nearest the ID (areas 1-4), the CI is found to be somewhat lower than points deeper into the PEX tube. This result seems to be contrary to the expectation of higher oxidation at the ID; however, none of the CI values were seen to change significantly.

Microscopic FTIR has also been used to measure the ratio of the  $731\text{ cm}^{-1}$  peak to the  $718\text{ cm}^{-1}$  peak in the methylene 'rocking' region. This ratio (crystallinity ratio) has been used previously to assess the local crystallinity of the PEX<sup>[13,14]</sup> expressed through the degree of cross-linking. The crystallinity ratio of the PEX at the ID (areas 1-4) is found to be lower than that in the tube interior, consistent with the expectation of more degradation of the polymer in contact with the water flow. Also, areas 1, 3, and 4 nearest the protrusion and dished region appear to be more degraded than a point on the ID further away from the protrusion.

**Figure 5.** Optical micrograph of the crack face of failure L1–2. The tube inside diameter is at the top of the image, and the image covers the outermost 10% of the tube diameter. About 80% of tube diameter was cracked by the action of chemical attack and the remainder by mechanical forces. The numbers indicate positions where microscopic Fourier transform infrared spectra were obtained. Carbonyl indices for positions (1–6) are 0.19, 0.19, 0.19, 0.20, 0.24, and 0.24. The crystallinity ratio for positions (1–6) are 0.50, 0.56, 0.52, 0.52, 0.66, and 0.65. [Colour figure can be viewed at [wileyonlinelibrary.com](http://wileyonlinelibrary.com)]

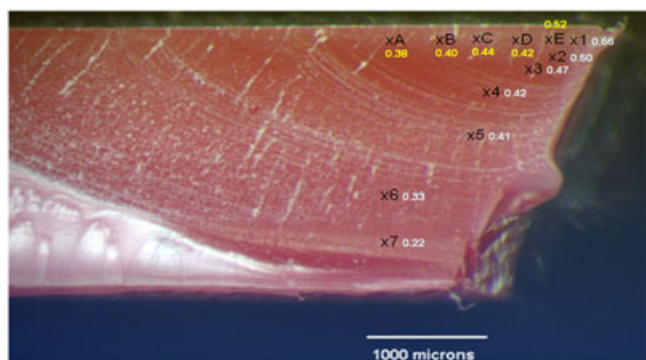
The crack faces from failure L2-2 (shown earlier in Fig. 2b and c) were analyzed by microscopic FTIR and by SEM-EDX. Figure 6 shows the CI values measured at different points on one of the faces. The CI values are highest at the point nearest the protrusion and dished region. The CI values at this point are about three times higher than those for failure 2 location 2, i.e. polymer oxidation is

**Figure 6.** Carbonyl index measurements along the crack face of failure L2–2. The highest carbonyl index values are found near the protrusion, and they decrease along the inside diameter from that point (yellow numbers) and also with depth into the crack (white numbers). [Colour figure can be viewed at [wileyonlinelibrary.com](http://wileyonlinelibrary.com)]

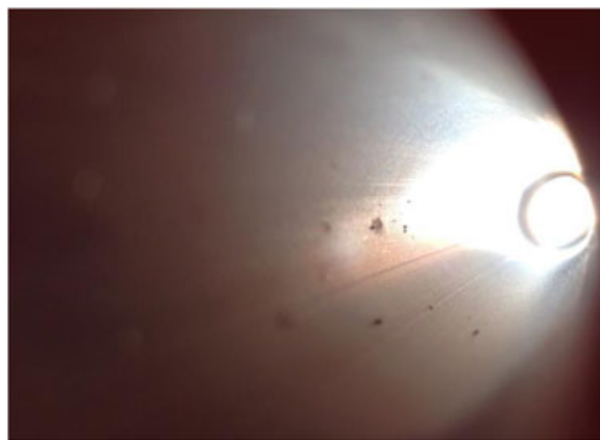
**Figure 8.** Back-lit macrograph of a tube interior from L1. Many micro protrusions of differing size are visible. [Colour figure can be viewed at [wileyonlinelibrary.com](http://wileyonlinelibrary.com)]

Every crack failure from the three locations studied in this work was found to have a polymeric protrusion of some size. Further, a less detailed study of failed samples from six of the seven locations showed that six of the locations had protrusions on their ID's that could be readily detected by back-lit optical inspection (See figure 8). By contrast, tubing samples recently purchased locally from stock were free of any such protuberances. This examination of tube ID's can be readily conducted on short samples using a camera on any modern mobile phone. Of course, a more elaborate inspection routine during manufacture could be conceived using a miniaturized camera on a flexible rod.

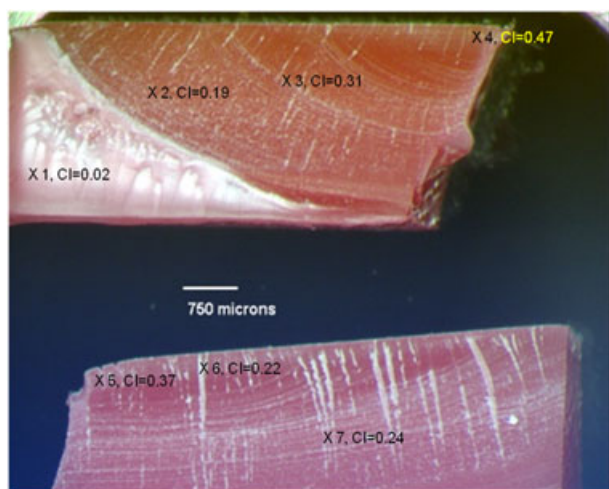
**Figure 7.** Chlorine concentrations along the crack face of failure L2–2 as determined by SEM–energy dispersive X-ray. The chlorine concentration is highest at the protrusion and dished area and lowest in that part of the crack that was opened by mechanical failure. These SEM–energy dispersive X-ray measurements were made after those using FTIR to reduce the possibility of degradation due to the e beam. [Colour figure can be viewed at [wileyonlinelibrary.com](http://wileyonlinelibrary.com)]

much higher. In Fig. 7, the chlorine concentrations determined by EDX are shown for locations on both sides of the cross section that split near the protrusion. The highest chlorine concentration (~0.7%

of all elements) is found close to the protrusion and dished region. Thus, there is a correlation between chlorine concentration and oxidation with both at a maximum near the protrusion.
