Analysis of polymer parts: buried problems

The analysis of manufactured parts for the source of defects is challenging as these defects are often buried below the surface. An example of this type of problem is a defect that occurs in a molded and multilayered painted part.

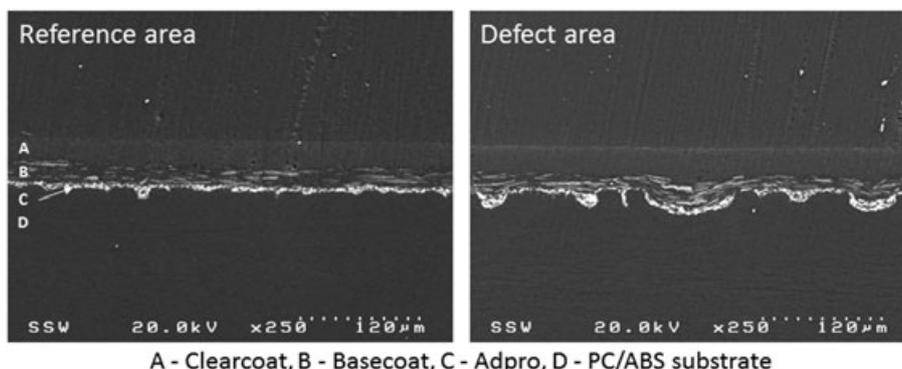
After mounting and polishing, the defect and reference samples were examined in cross section by both optical microscopy and SEM. The images of the cross sections are presented in Fig. 1. Evident in the cross section are a number of layers; the substrate, the adpro, the basecoat layer containing the aluminum flake and the clearcoat layer.

The substrate in the defect area shows an undulating surface that is replicated in the adpro layer and the basecoat layer. The substrate in the reference area shows the surface as being fairly smooth.

The cause of the undulation on the surface of the substrate in the defect area is unknown at this point. As the defect always occurs in the same area of the part, the most likely explanation is a series of scratches or perturbations on the mold surface that are being replicated on the surface of the molded part and, subsequently, in the adpro and basecoat layers.

Figure 1. Scanning electron microscopy images of mounted cross sections of the fully painted part in the reference and defect areas showing the undulating layers under the surface in the defect area. The various layers are labelled.

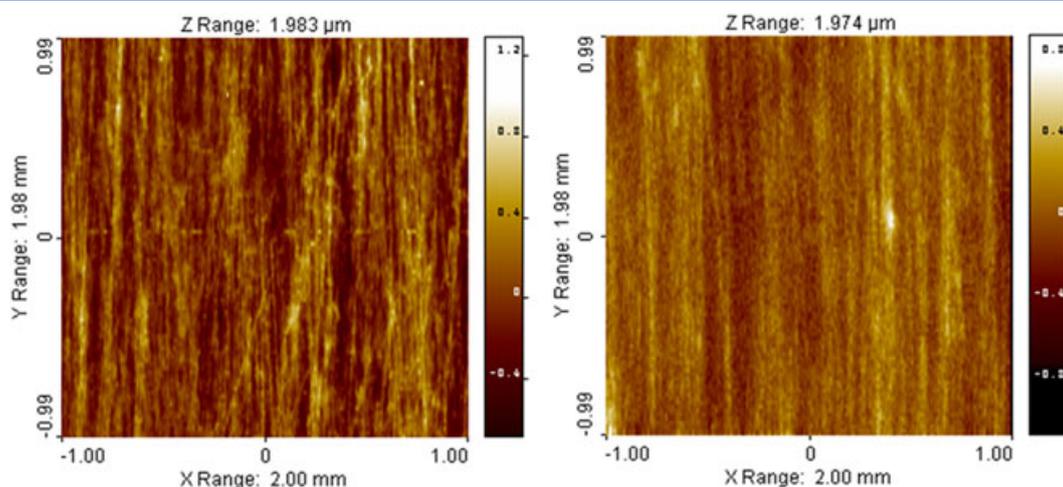
On receipt of the raw molded parts, they were examined using surface profilometry for the possible presence of scratches or roughness that would result in the formation of the defect of interest. No roughness or scratches were noted on the raw parts in the defect area as shown in the images presented in Fig. 2. The undulating surface is not the result of a defect in the mold.

Figure 2. Surface profiles of the raw parts in the affected areas showing similar ranges in the Z-direction.

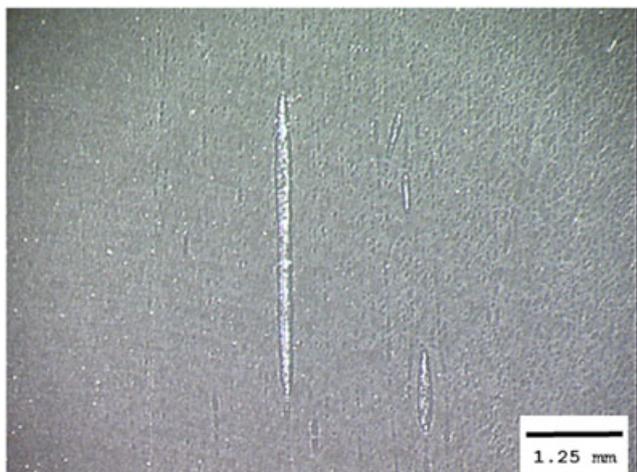
examination by optical microscopy showed the appearance of an apparent scratch on the surface in the defect area as shown in Fig. 3. The large scratch was surrounded by smaller 'scratches'. The surface of the part was analysed by surface profilometry in an area with 'scratches' and an area away from the 'scratches'. The scratch was approximately 200 microns wide and 35 microns deep. No features of this type had been seen on the raw parts. Based on this information, the application of the adpro is causing significant changes on the surface of the molded raw part.

Figure 3. Optical image of a part in the defect area with only adpro applied. Note the appearance of the 'scratch-like' features.

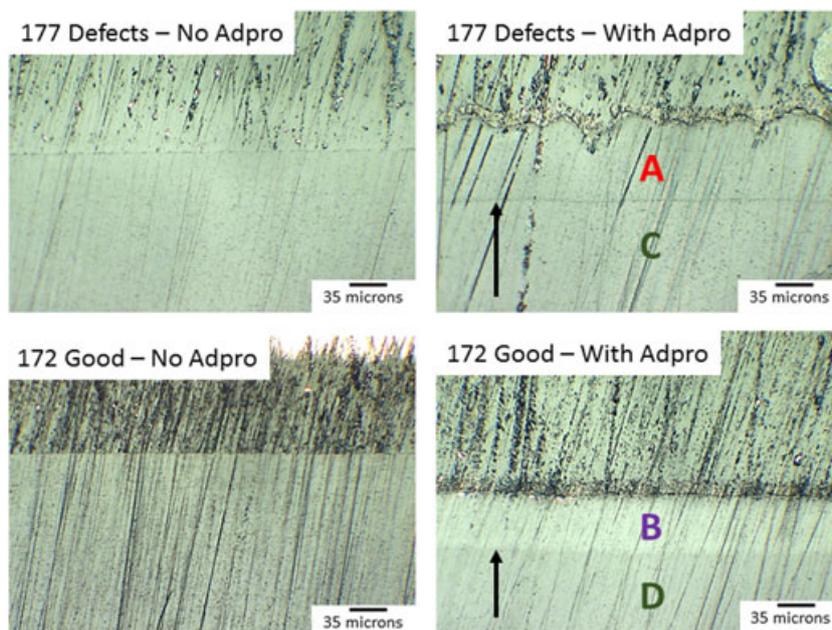
Having the XPS data indicate that there was a variation in the composition at the surfaces of the molded parts led us to further examine the mounted cross sections of the parts exposed to adpro. On this further examination, it became apparent that there was an effect from the adpro on the underlying PC/ABS substrate. As can be seen from the images in Fig. 4, there was a line in the substrate below where the adpro was applied. The line was missing where there was no adpro applied.

Figure 4. Optical images of the cross sections of raw molded parts with and without adhesion promoter (adpro) applied. Sample 177 showed defects while sample 172 did not. Note the appearance of a line, well below the interface, where the adpro was applied. The areas labelled A, B, C and D were analysed by Fourier transform infrared spectroscopy.

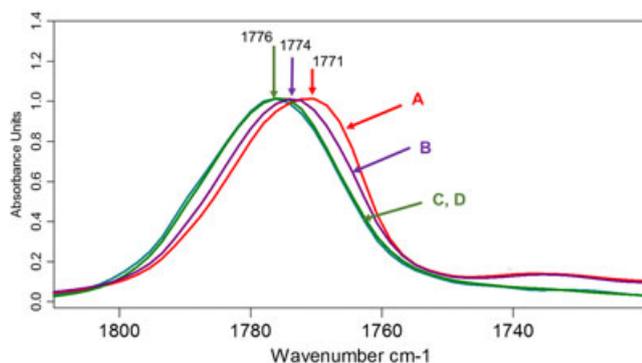
The cross section was examined by FTIR to see if the difference between the layers could be determined. The layers of reference substrate (below the line) on both samples, and the material between the lines and the adpro on both samples, were analysed by FTIR. The spectra are compared in Fig. 5. One can see from the comparison that the carbonate peak in the spectra collected from the substrates away from the exposure to adpro is situated near 1776 cm⁻¹ for both samples. For the sample with a smooth interface between the substrate and the adpro, the peak has shifted from 1776 to 1774 cm⁻¹. For the sample with the undulating interface, the carbonate peak has shifted to 1771 cm⁻¹. Based on the literature, the shift of this peak to lower wavenumbers is indicative of increased crystallinity of the PC portion of the polymer substrate.^[13] Based on this result, the PC appears to have become more crystallized on exposure to the adpro. Although some crystallization was noted in the polymer wherever the adpro was applied, it was the greatest in the areas showing the formation of the undulating interface.

Figure 5. Fourier transform infrared spectroscopy spectra of the carbonyl region of the polycarbonate and acrylonitrile/butadiene/styrene in the four areas indicated in Figure 4. Note the shift to lower wavenumbers, indicating increasing crystallization of the polycarbonate portion of the alloy.

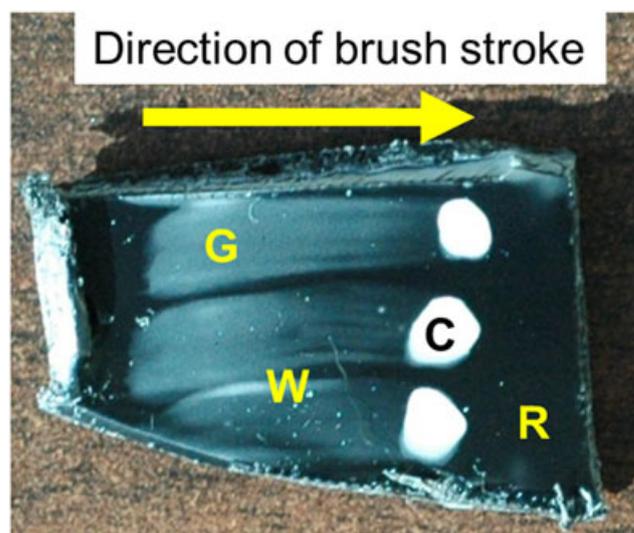
The solvent mixture was brushed onto the surfaces of the raw parts that had shown a response to the adpro and those that had not. The solvent evaporated quickly from the surface. The effects of the solvent on the polymer surfaces were dramatic, as shown in the optical image in Fig. 6. The surfaces of the solvent-exposed parts were further examined by SEM. The images are labelled as grey area – least exposure to solvent, white area – where two brush strokes overlapped and white circle – the end of the stroke with the most solvent exposure. One can see from the images in Fig. 7 that the solvent has an effect on both types of raw surfaces but, on the surface that showed little response to the adpro, the effect is that of a fine open structure at the surface. The raw surface that showed a significant response to the adpro showed a significant response to the solvent. A lower magnification image of the surface of the highly affected surface is presented in Fig. 8. These features are very similar to those seen in the painted defect area of the finished manufactured part.

Figure 6. Image of the raw part after the application of the solvent portion of the adpro. The areas analysed by scanning electron microscopy are indicated by the letters G (grey area, single stroke), W (white area, overlapping strokes), C (end of a stroke where a droplet formed) and R (reference area).

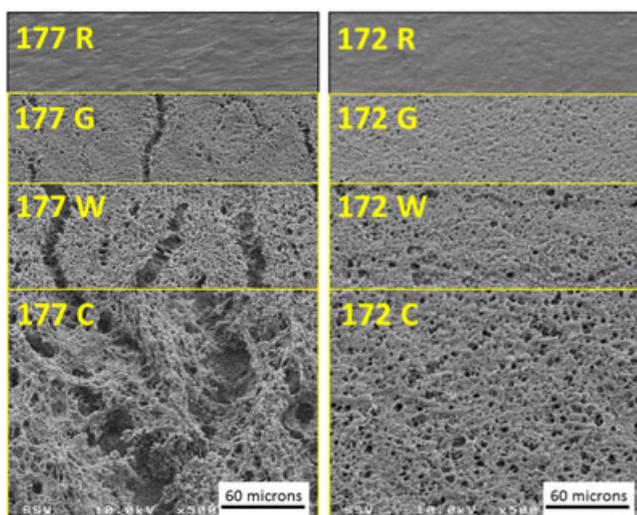
Figure 7. Scanning electron microscopy images of the surfaces of raw part 177 showing defects and raw part 172, a good part. The letter 'R' indicates an area prior to exposure to the solvent. The letters G, W and C indicate the areas shown in Figure 6.

carbonate/nitrile groups across the surface and in cross section. SEM images of the surfaces of the defective and good PC/ABS parts after exposure to the solvent portion of the adpro show that the morphologies of the surfaces of the parts are strikingly different.

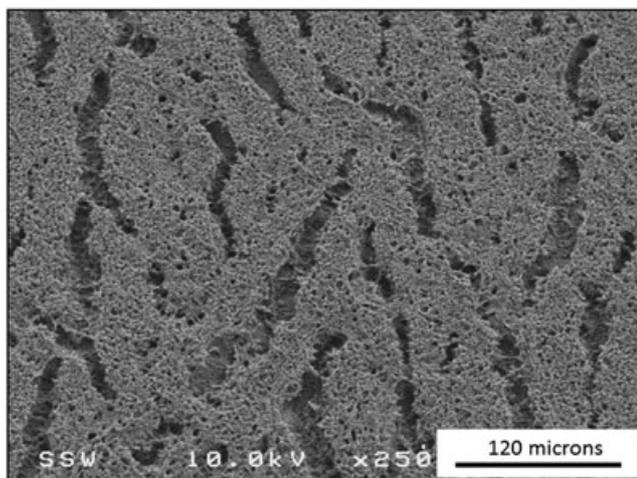
Figure 8. Scanning electron microscopy image of the surface of raw part 177 after exposure to solvent. Parts of this type showed the presence of defects on painting.
