■ CASE REPORT

Damage of an Oxinium femoral head and polyethylene liner following 'routine' total hip replacement

J Bone Joint Surg [Br]
2011;93-B:409-13.

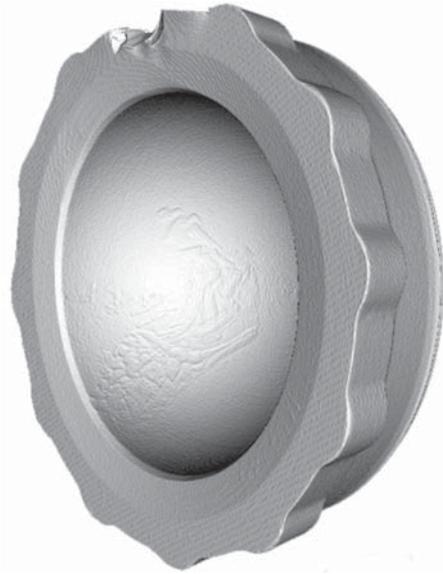
Fig. 1

Micro-CT scanned image showing the polyethylene liner at retrieval. Damage to the articular surface is broad in the medial/anterior area of articulation.

Results. Surface damage, in the form of deep scratches and gouges, was readily apparent to the naked eye on the polyethylene liner. Using a micro-CT imaging technique⁷ the liner was imaged (Fig. 1). A map of the surface deviation was created with specialised software (Geomagic Qualify (Geomagic Inc., Durham, North Carolina)) (Fig. 2). Analysis demonstrated surface deviations in the cross-linked polyethylene surface ranging from 14 μm to 38 μm in depth.

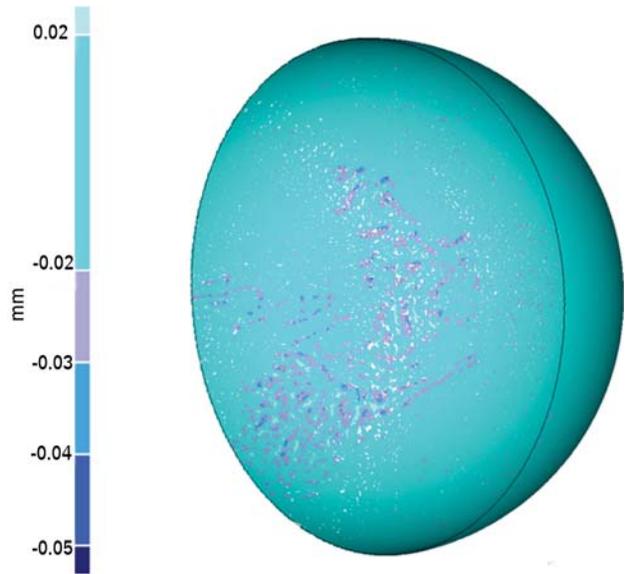
Fig. 2

Surface deviation map showing the polyethylene liner (constructed from micro-CT image with Geomagic software). Gradient scale depicts depth of damage to articular surface.

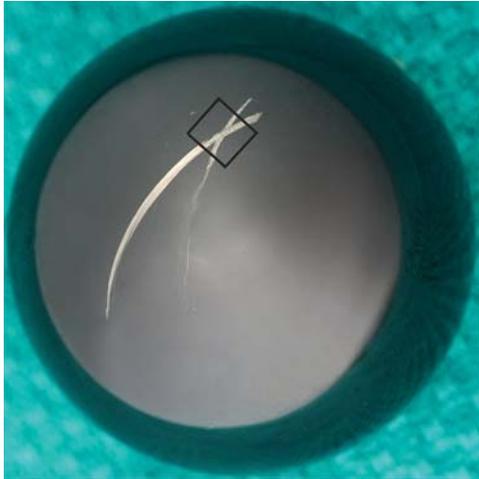
Fig. 3a

Digital photographs of the retrieved Oxinium femoral head, showing a) two obvious damage features, potentially material transfer from the acetabular shell or scratches through the Oxinium surface, and b) a stereo-microscope image (20 × magnification) of the intersection of the two damage features, which appear to be scratches with suspected titanium transfer from the acetabular shell.

The Oxinium femoral head was inspected and demonstrated an intersection of two material transfers/scratches on the articulating surface (Fig. 3a). Attention was focused at the intersection and was photographed with a stereomicroscope at 20 \times magnification (Fig. 3b). The area of interest underwent SEM imaging at various magnifications (Fig. 4). This revealed damage to the surface consisting of a raised area (possible titanium transfer from the acetabular shell), deep scratches in the oxidised zirconium surface with possible exposure of the underlying zirconium substrate,

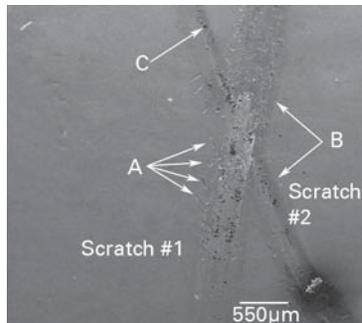
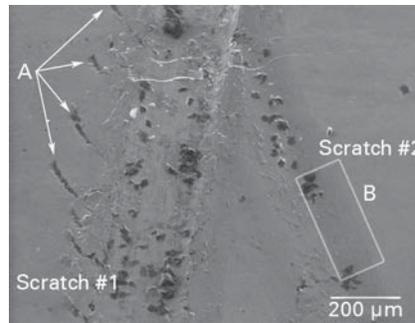
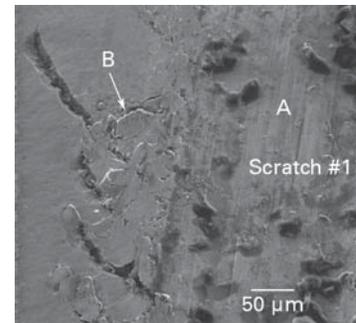
Secondary electron images showing macro and micro damage to the Oxinium coating at different levels of magnification. Figure 4a (magnification × 30) – there appears to be a tangential pattern of surface fatigue bordering scratch 1 (A). Darker borders of the scratches (B) may represent the transfer of titanium from the acetabular shell. The darker debris (C) is carbon rich, possibly polyethylene debris or organic material. Figure 4b (magnification × 100) – the tangential pattern of fatigue (A) suggests that Oxinium has flaked off the surface of the femoral head along the outer edges of scratch 1 and in part on scratch 2. Hairline cracking is visible (B) along scratch 2. Figure 4c (magnification × 250) – surface fatigue has resulted in the loss of the Oxinium surface, exposing the zirconium substrate (A). Granules of oxidised zirconium that are about to flake off are identifiable (B). Extensive surface cracking has occurred.

and tangential cracking along the edges of the scratch damage. Examination at higher magnification (Fig. 4c) clearly showed the presence of smaller cracks in the Oxinium coating. These cracks indicated that the coating had been damaged and could delaminate or flake off at any time. Back-scattered electron imaging revealed the difference in composition of the materials based on atomic number differences (Fig. 5). Elements with higher atomic numbers back-scatter electrons more strongly than those with a lower atomic number, thus appearing brighter in the image. Energy-dispersive x-ray intensity element maps were obtained for the area shown in Figure 6. These maps clearly showed the spatial distribution of the major elements of interest (oxygen, titanium, aluminium, zirconium and

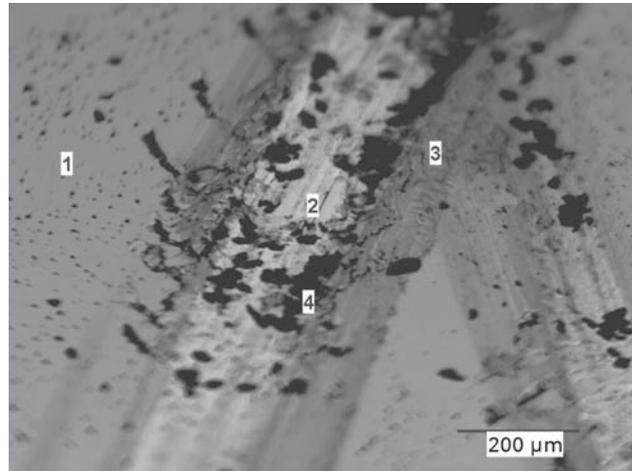
Fig. 5

Back-scattered electron image showing the damaged region of interest. Region 1 is the undamaged oxidised zirconium surface. The brighter scratched region (2) is the underlying metal substrate (the Oxinium coating has been removed). Region 3 is titanium transfer from the acetabular shell. Dark regions (4) are carbon-rich material.

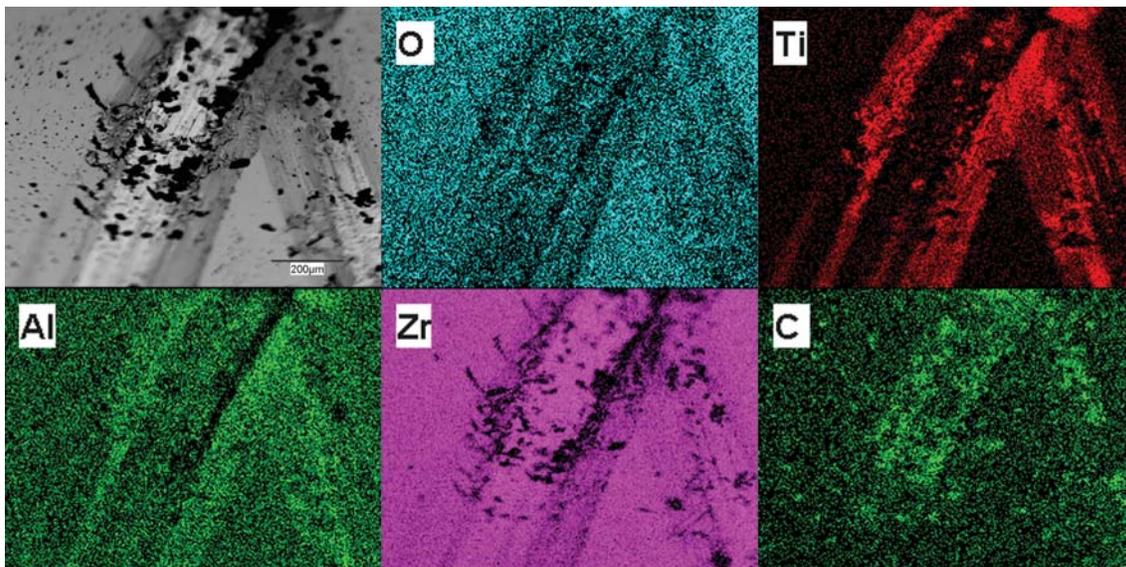
Fig. 6

Back-scattered electron image and energy dispersive x-ray intensity element maps showing the concentration of major elements at the damaged region of interest. Image intensity is directly proportional to the element concentration. O, oxygen; Ti, titanium; Al, aluminium; Zr, zirconium; C, carbon. The O intensity is much weaker, while the Zr intensity is much higher, confirming the complete loss of the oxidised zirconium coating in this area. The concentration and distribution of material transfer from the acetabular shell is well-represented with the mapping of Ti and Al.

carbon). The oxygen map confirmed the presence of oxidised zirconium on either side of the damage and scratched regions. The lack of oxygen detected in the scratched region clearly indicated that exposure of the underlying femoral head substrate had occurred. The titanium and aluminium element maps confirmed that metal transfer from the acetabular shell had also occurred. The carbon-rich deposits were further analysed with Fourier transform infrared spectroscopy which identified them as organic in nature, most likely fibrinous deposits, rather than polyethylene.
