RADIOLYTIC CORROSION OF CU NUCLEAR WASTE CONTAINERS

ABSTRACT

The corrosion of copper is being studied under the aerated vapour conditions which could prevail in the early period after nuclear waste container emplacement in a deep geologic repository. Exposure experiments are being conducted at two relative humidities (70% and 85%) in the presence and absence of a low γ -radiation dose rate (0.35 Gy/h). Corrosion is observed to occur generally across the surface yielding a film of Cu_2O , the surface of which eventually becomes oxidized to CuO . This process is accelerated by the presence of a radiation field. The breakdown of this layer leads to dissolution as Cu^{2+} and its redeposition to form CuO . This conversion process spreads across the surface rather than penetrating into it and appears also to be accelerated by the presence of radiation. At the higher relative humidity some pitting occurs. The absence of cupric nitrate deposits shows that, despite the formation of nitric acid, no nitrogen fixation occurs.

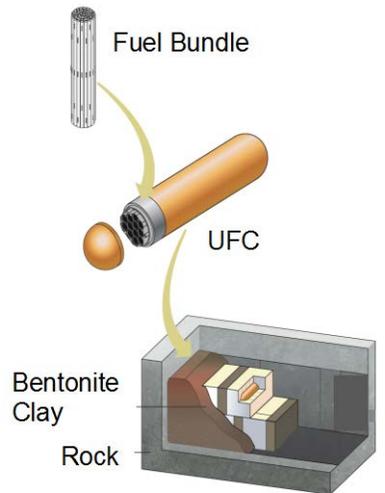
Figure 1: A schematic illustration of the multiple-barrier system proposed for the permanent disposal of spent nuclear fuel in a Deep Geologic Repository.

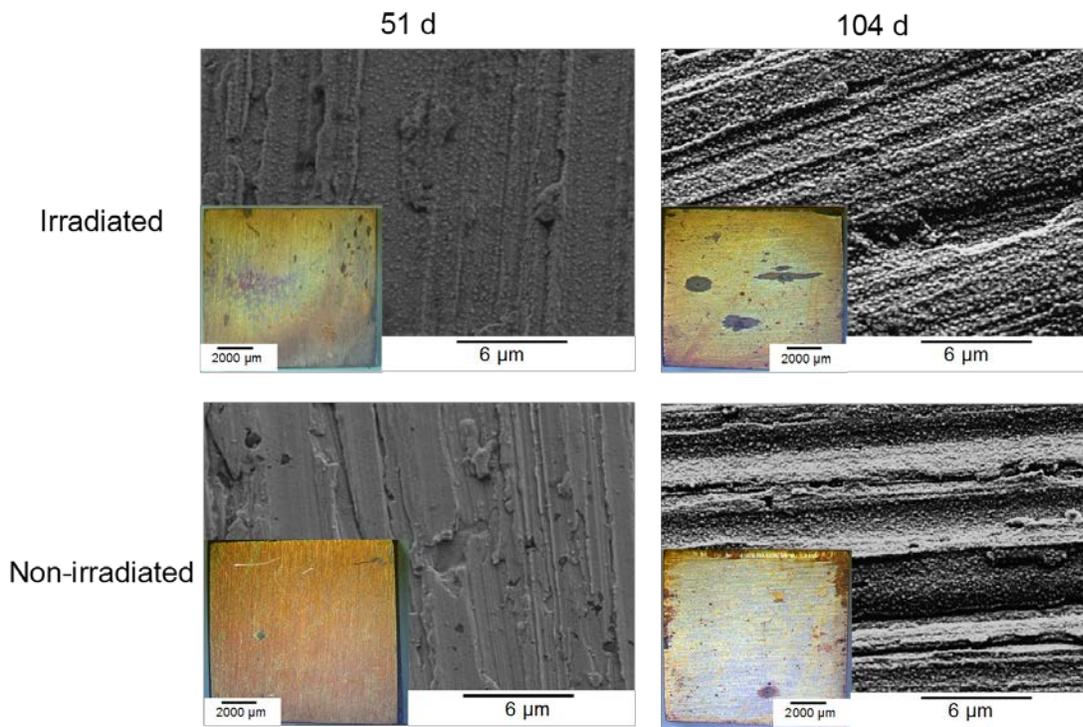
Figure 2: SEM micrographs of the surfaces of coupons exposed in the radiation experiment for different periods showing corrosion of the general areas (copper coloured) in the corresponding optical images.

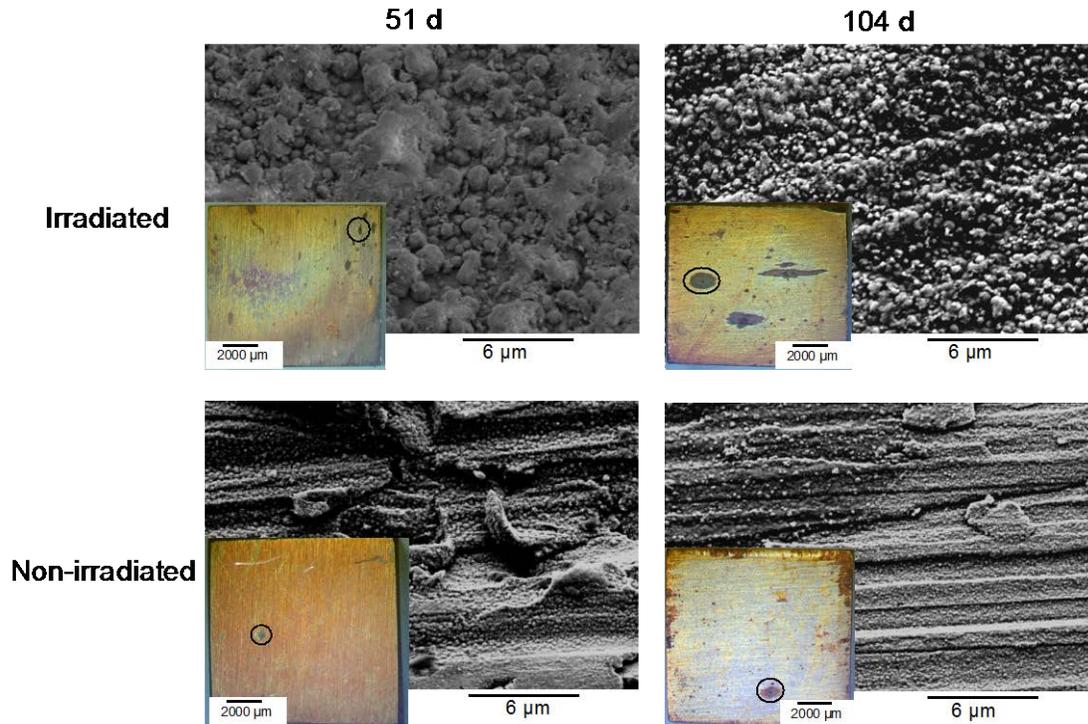
Figure 3: SEM micrographs of the surfaces of samples exposed in the radiation experiment for different periods showing the corrosion within the patches marked with circles in the optical images.

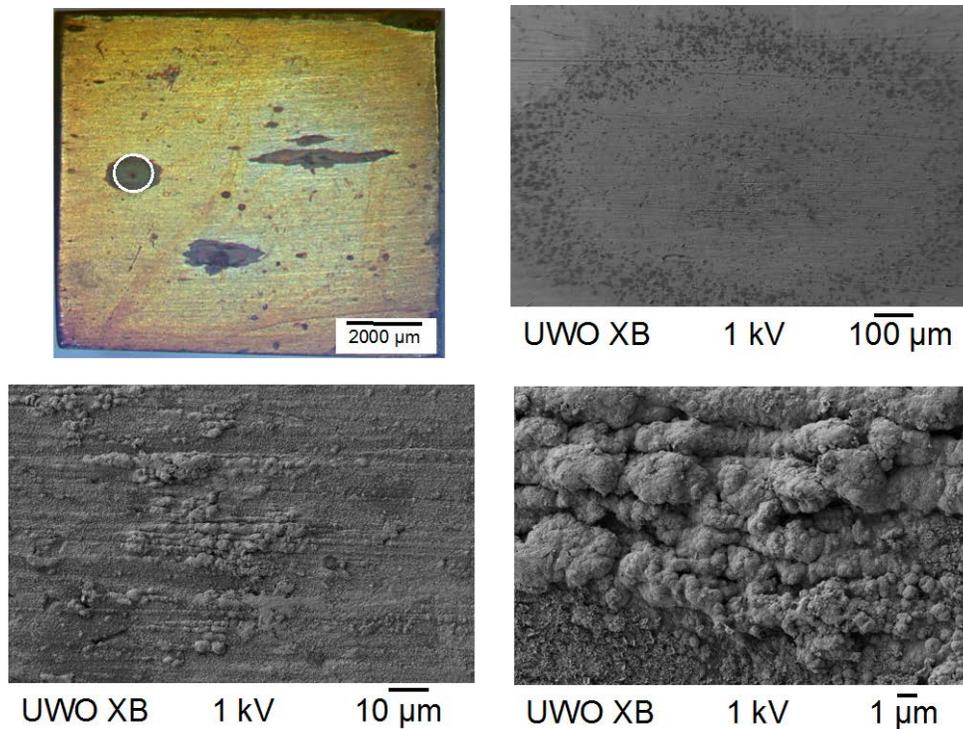
Figure 4: Optical images and SEM micrographs recorded on a sample exposed to irradiated vapour for 104 days. The circled patch shows the locations examined by SEM. The morphology of the corrosion product in the central dark spot can be observed.

Patches, irrespective of whether γ -radiation was present or not, grew with a central accumulation of corrosion product. In optical images this can be seen as a central dark spot within the patch, and in SEM micrographs as an accumulation of larger globular deposits as shown in Figure 4. As shown in the figure, this accumulation tends to be concentrated along the original polishing lines. This choice of location could be dictated by two features: the more likely accumulation of water within the polishing grooves, and/or the greater likelihood of stress-induced fracture of the more general corrosion film initially forming at this location.

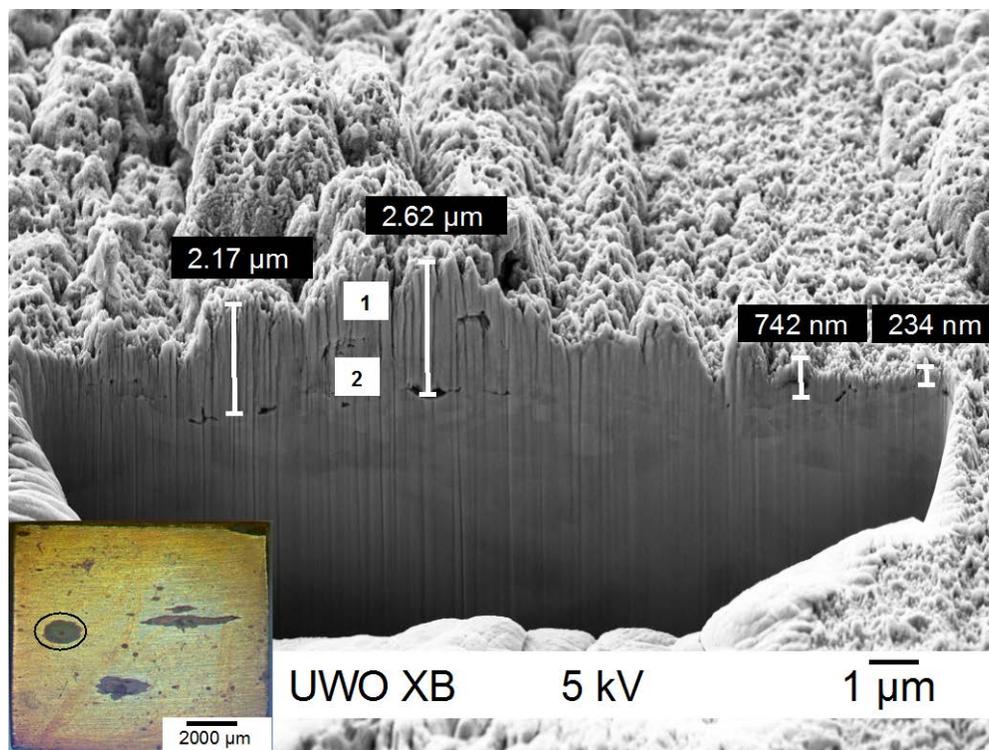
Figure 5: A FIB cut cross section of an irradiated sample exposed for 104 days. The section was cut from within the circled area shown in the optical image. The numbers in the SEM micrograph indicate the locations analyzed by EDX (Table 1).

The suspicion that the extent of corrosion at these locations is greater is confirmed by the SEM micrographs recorded on FIB-cut cross sections. Figure 5 shows the thickness of the corrosion product varies with location from 234 nm at the thinnest location to 2.62 μ m at the thickest location. Additional cross sections (not shown) cut \sim 50 μ m inside and outside the patch showed that the film thickness varied from \sim 60 nm to 176 nm at locations in the general area to 160 nm to 390 nm within the patch. Inspection of the metal/deposit interface shows that, despite these differences in thickness of the deposit, the observed depth of corrosion penetration into the metal is only slightly greater beneath the thicker than the thinner deposit.

Table 1: EDX data recorded on the cross-section of a patch on an irradiated sample after 104 days of exposure. The locations analyzed are numbered in Figure 5.

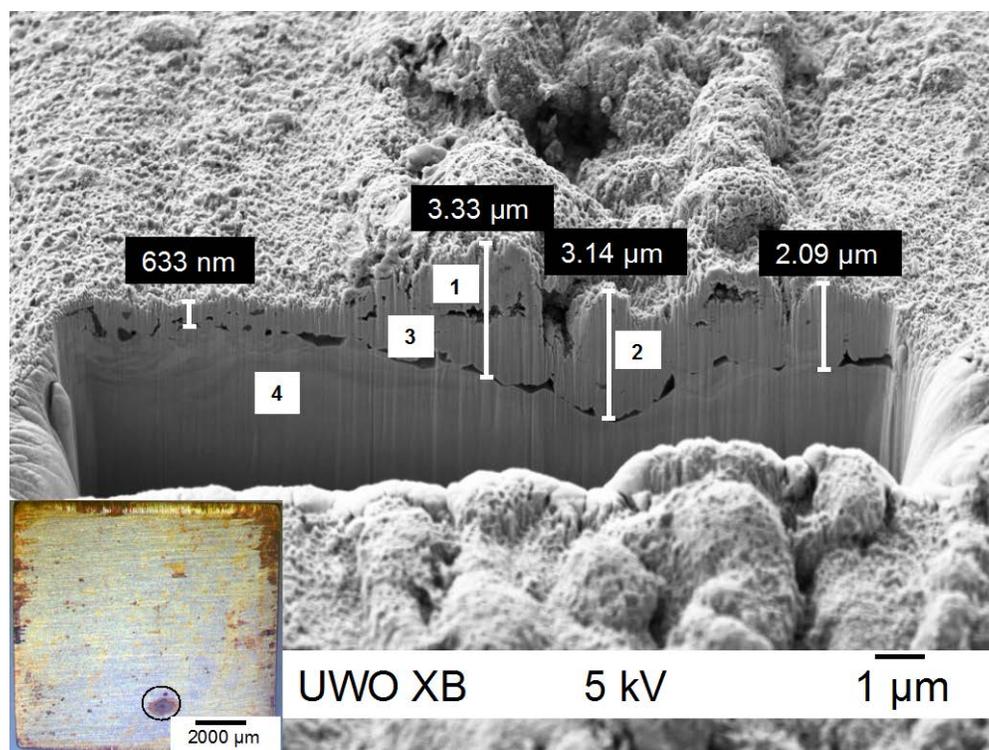
Figure 6: A FIB cut cross section on a non-irradiated sample exposed for 104 days. The section was cut from within the circled area shown in the optical image. The numbers in the SEM micrograph indicate the locations analyzed by EDX (Table 2).

A similar FIB cross section cut through the central mass of corrosion product within a patch on the unirradiated sample (after 104 d of exposure), Figure 6, shows both a thicker deposit (up to 3.33 μm) and an apparently greater depth of corrosion penetration than on the irradiated sample exposed for the same duration. A number of additional features are also visible; (i) the deepest penetration is not beneath the thickest deposit; (ii) considerable void space exists both in the deposit and along the deposit metal interface. Beyond this more heavily corroded region (towards the left edge of the FIB section) the penetration depth is limited to ~ 633 nm which is similar to the penetration depths observed on the irradiated sample at locations away from the central core of the patch.

Table 2: EDX data recorded on the cross-section of a patch on a non-irradiated sample after 104 days of exposure. The locations analyzed are numbered in Figure 6.

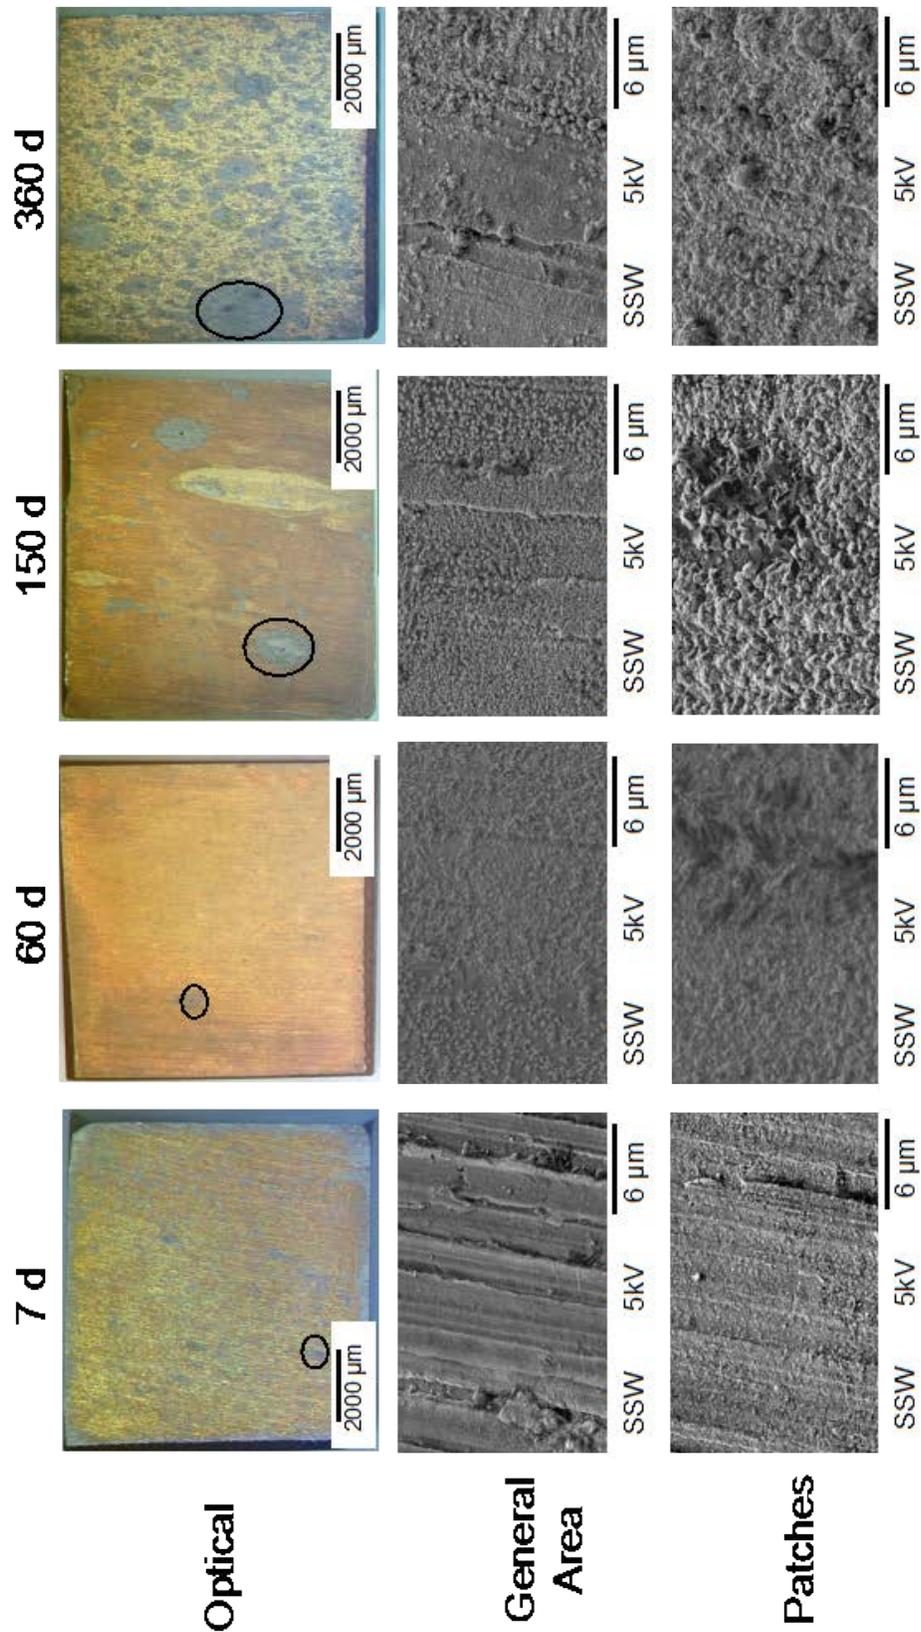
Figure 7: Optical images and SEM micrographs of samples (non-irradiated) removed from the humidity chamber after a number of exposure periods. The circles in the optical images indicate the locations shown in the SEM micrographs.

A similar analysis was performed on specimens exposed in the humidity chamber with both general corrosion and more extensively corroded patches being analyzed. Presently a full analysis of exposed samples has not been completed. Figure 7 shows a series of optical images and SEM micrographs recorded after 7, 150 and 360 days of exposure (70 $^\circ\text{C}$, 75% RH). After 7 days only a few small dispersed globular features are observed with a noticeable increase after 14 days. After 150 days the deposit is more uniform, although the optical image of the surface after 360 days shows the presence of such deposits can be patchy.

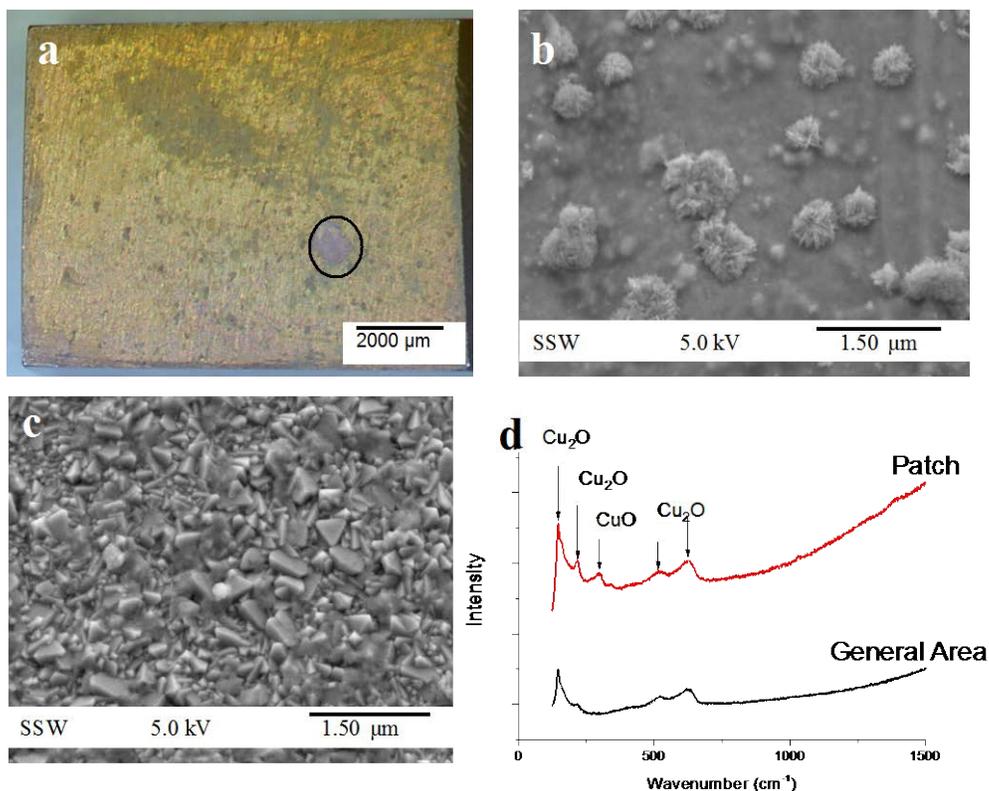
Figure 8: Optical (a), SEM micrographs ((b) and (c)), and Raman spectra (d) recorded on samples (non-irradiated) removed from the humidity chamber after a 30 day exposure. (b) shows the general corroded area: (c) shows the micrograph recorded on the patch marked with a circle in (a). The Raman spectra in (d) are for a general area and a patch.

Figure 8 shows a more extensive analysis of both a general area and a patch after 30 days of exposure. The more extensively corroded patch analyzed is indicated by the circle in the optical image, Figure 8(a). In the general area, Figure 8(b) the surface is uniformly oxide covered with small areas of clustered ill-

defined crystals. It is likely that these small clusters are the sites at which breakdown of the surface film occurred followed by the subsequent deposition of a corrosion product leading to repair of the site. Within the patch, Figure 8(c) the corrosion deposit is more copious and in the form of accumulated crystals indicating some local aqueous transport prior to deposition. This suggests the presence of condensed water at these locations despite the lower RH (70%) in these experiments compared to the irradiated experiments (85% RH).

Raman spectra recorded on the sample exposed for a 30 day period, Figure 8(d) show the peaks at 147, 220, 525 and 625 cm^{-1} demonstrating the presence of Cu_2O in both the generally corroded areas and the patches. However, after 30 days CuO , indicated by a peak at 297 cm^{-1} , is only observed within the patches, Figure 9(d). Raman spectra recorded on samples exposed for 60 and 90 days show that a weak CuO Raman signal is observed on the surface of the general area, only a few locations being free of CuO . In addition the CuO Raman signal for locations within the patches becomes stronger. These observations indicate that the general oxidation of the surface increases with time of exposure. These differences persist over the longer exposure periods. As observed for the irradiation experiments, XPS shows Cu(II) to be the dominant Cu oxidation state in both areas (87%), Table 3. This is higher than the 75% for Cu(II) observed in the higher RH experiments with and without irradiation, and suggests that the conversion of the outer regions of a Cu_2O film to CuO is more readily achieved at the lower RH.

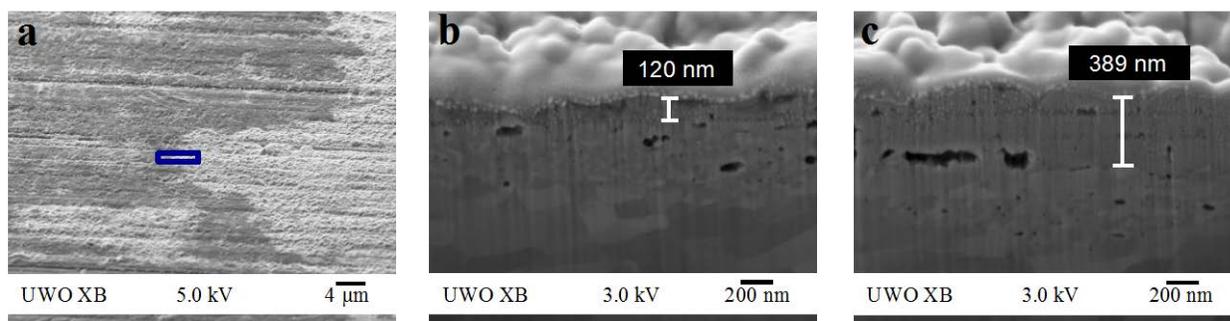
Figure 9: An SEM micrograph (a) recorded on a sample removed from the humidity chamber after a 30 day exposure. (b) and (c) show FIB cut cross sections across a border between a general corrosion area and a patch (the location of the cut is shown in (a): (b) shows the section in a general corroded area; (c) shows the section within the patch.

FIB cross sections were cut at the centre of the patch (the lighter area in the optical image) and across the border between a patch and a generally corroded area (as indicated by the line in the optical image, Figure 9(a). Near the centre the thickness of the corrosion product was in the range 300 to 475 nm (not shown). Across the border between the patch and the generally corroded area (the darker area), the film was 389 nm thick within the patch, Figure 9(c). Outside the patch the film may be considerably thinner as indicated by the 120 nm scale marker. Presently, the location of the Cu/film boundary is uncertain, but may be located just below the voids visible at approximately the same depth at both locations. If this proves to be the boundary then the film thickness inside and outside the patch may be the same, and the 120 nm scale marker in Figure 9(b) may indicate the location of an outer oxide with different properties/composition to the thicker sublayer. Additional cross sections are under investigation to identify unequivocally the location of the interface. Irrespective of this uncertainty, the penetration depths within the patches appear to vary little across the patch, again demonstrating that corrosion spread across the surface rather than penetrated into it. Additionally the depth of penetration in the general areas and within the patches are similar to those observed on the irradiated samples (discussed above), except for the absence of the more deeply penetrated central spots covered by a much thicker deposit.
